## Supplemental Information for 021-511 or 120694 Angle Drive (Speedometer Cable to Gearbox) Austin Healey BN4-BJ8, MGB 63 on, TR'S 63 on

# TECHNICAL SERVICE BULLETIN

Re: Right Angled Speedometer Adaptor Failures

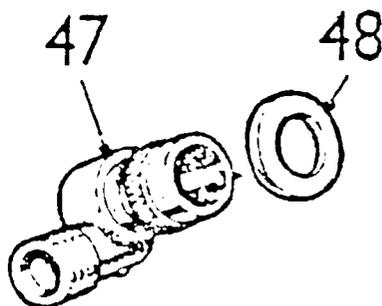
WASHER 3H 550

Repeated failures of the above have, in many instances, been caused by Washer-Adaptor to gearbox Part Number 3H 550 not being fitted when a new right angled drive adaptor is installed.

This causes an excessive end load and premature failure of the right angled drive pinion.

***IMPORTANT! When fitting the angle drive, fit a 324-720 or 3H550 washer as shown on the next page.***
