Supplemental Information & Instructions for

Premium Ignition Rotors

151-805 or GRA2101HQ for MGT, MGA, SPM 948-1275, TR2-4A 872-785 or GRA102HQ for Healey 100-6/3000, MGC, TR250, TR6 to 1974

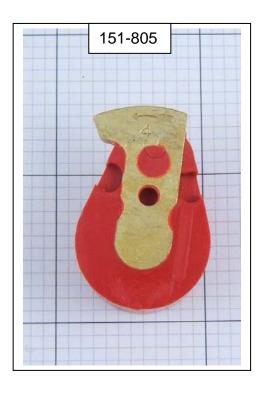
Rotor arms manufactured over the last decade are not exactly like the Lucas rotors (1a, 2a) made in the 50s and 60s. Specifically, these rotors (1b, 2b) have more carbon black in the plastic, which increases the conductivity of the material. On top of that, the original contact was molded into the body of the rotor (1c) while replacement rotors use a rivet. The lower end of the rivet is very close to the spring clip (2d) on the underside of the rotor. There is simply not a lot of insulating material separating the tip of the rivet and the spring clip. The high energy spark from the coil (30,000 volts or more) will always follow the path of least resistance. In some of these rotors, this path goes from the tip of the rivet, through the thin layer of more conductive plastic, through the spring clip on the underside of the rotor arm, finally grounding out on the shaft of the distributor. Initially when this happens one or more of the spark plugs will fail to fire. This "miss" will sometimes heal itself if the engine is given a chance to cool off, but it always comes back, and in the end, the rotor will simply short out completely, which could leave you stuck

- The Premium Ignition Rotors we offer for Lucas distributors are based on the rotors made by Lucas in the
- 42 1960s for 4 and 6 cylinder applications. These rotors (3a, 3b) are manufactured from a highly non-
- 43 conductive resin ideally suited for modern high-energy ignition systems. The brass contact is molded to
- 44 the body when the body is made, eliminating the rivet. There is no chance for the contact to ground
- 45 through to the distributor shaft. The socket is precisely sized, which, combined with the spring clip (3c),
- ensures that the rotor fits tightly on the distributor shaft. All of these factors combined make these
- 47 Premium Rotors far superior to the other rotors available at this time, and this is reflected in the fact that
- 48 they are warranted against defects in material and/or workmanship for three years.

After years of use, the top of the distributor shaft may have been repeatedly cleaned with wire brushes or emery cloth. Our supplier, who sees hundreds of used distributors every year, reports that it is quite common to see distributor shafts with a smaller outside diameter. As a result, a new rotor at the upper end of the original tolerance range may not fit snugly on the shaft. These Premium Rotors have a tighter tolerance on the inside diameter with less variation between rotors, both of which help ensure a snug fit on a used distributor shaft.
