Supplemental Information & Instructions for **031-390 or 1G4349K Fulcrum Pin & Bush Kit** MGB, MGC, Austin Healey 100-3000

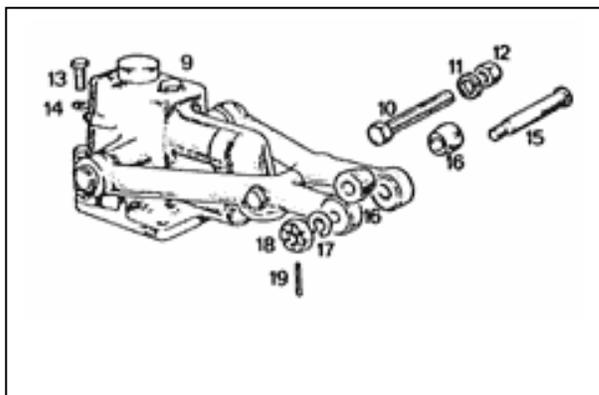
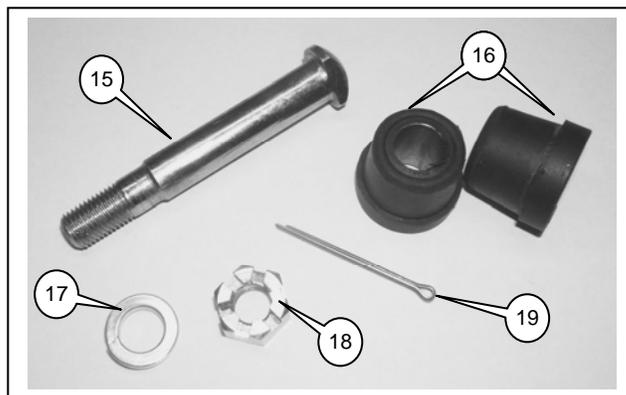
Ref	Qty	Moss US	Moss Europe	Description	Notes
15	1	263-440	1G4349	Pin, fulcrum	drilled for cotter pin
16	2	282-305	8G621	Bushing, rubber, sleeved	
17	1	324-250	GHF334	Washer, lock, 7/16"	
18	1	310-330	NL607041	Nut, slotted, 7/16 UNF	
19	1	325-330	GHF502	Cotter pin, 3/32 x 1 1/2"

We have been told that at one point a BMC replacement bushing was available that allowed the upper bushings (16) to be replaced on the Austin Healey without loosening the bolt (10) that holds the shock arms together and prying them apart slightly. That bushing is no longer available, and the installation of the upper trunnion with the bushings is easier if you loosen the bolt and separate the arms a little. This procedure is specifically called out in the MGB & Healey workshop manuals, but the language is confusing.

We have gone to some trouble to supply a proper fulcrum pin drilled for the cotter pin so that you can use the same type of slotted nut originally used. The slotted nut will sometime hang up on the pin in the area where the hole was drilled. You may find it helpful to run a 7/16" UNF (20TPI) thread chaser or a die down on the first 1/2 inch of the threaded end of the pin. We apologize for the inconvenience, and we are working with our suppliers to make this additional step unnecessary.
