## Premium Ignition Rotors

PART# 151-805 or GRA2101HQ, 151-865 or GRA2114HQ, 872-785 or GRA102HQ

### Installation Instructions

**For: MGT, MGA, SPM 948-1275, TR2-4A;  
Healey 100-6/3000, MGC, TR250, TR6 to 1974**

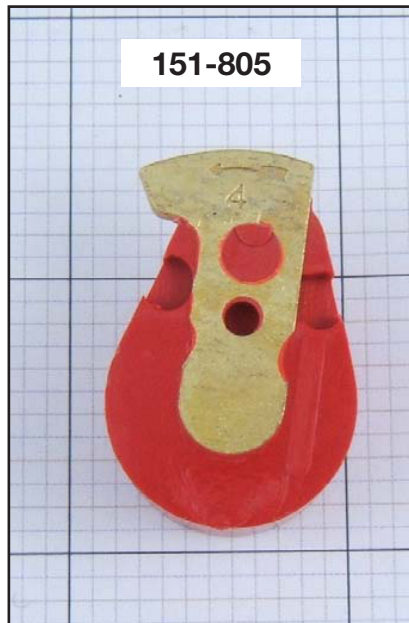
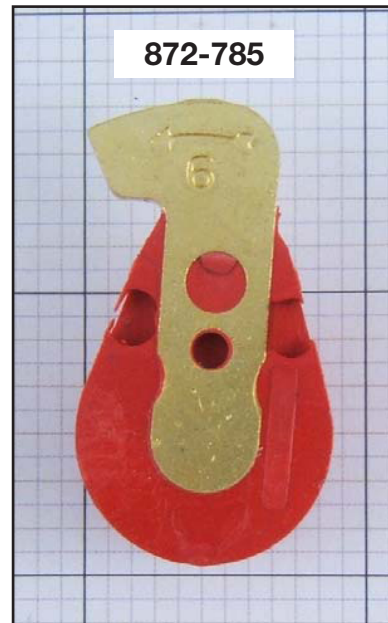
Rotor arms manufactured over the last decade are not exactly like the Lucas rotors (1a, 2a) made in the 50s and 60s. Specifically, these rotors (1b, 2b) have more carbon black in the plastic, which increases the conductivity of the material. On top of that, the original contact was molded into the body of the rotor (1c) while replacement rotors use a rivet. The lower end of the rivet is very close to the spring clip (2d) on the underside of the rotor. There is simply not a lot of insulating material separating the tip of the rivet and the spring clip. The high energy spark from the coil (30,000 volts or more) will always follow the path of least resistance. In some of these rotors, this path goes from the tip of the rivet, through the thin layer of more conductive plastic, through the spring clip on the underside of the rotor arm, finally grounding out on the shaft of the distributor. Initially when this happens one or more of the spark plugs will fail to fire. This “miss” will sometimes heal itself if the engine is given a chance to cool off, but it always comes back, and in the end, the rotor will simply short out completely, which could leave you stuck on the side of the road.
