# Pressing Axles into Wire Wheel Hubs for the MG TC

## 265-140 & 265-150 Wire Wheel Hub, Rear

## 453-210 Axle Shaft & 453-185 Axle Shaft, Nitrided

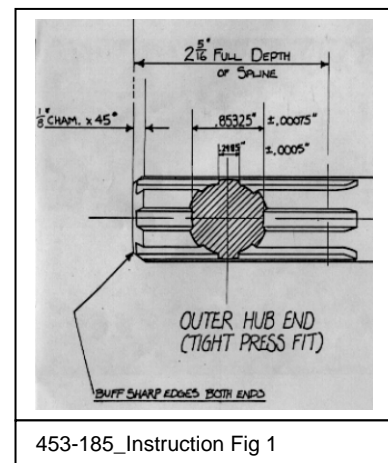
453-185\_Instruction Fig 1

- 1) The gap between the crest on the axle and the root on the hub should be between 5 and 23 thousandths of an inch. That gap is intentional and it is the source of the oil that seeps past the axle into the outer cup in the hub. More about that later.
- 2) The "groove" in the axle is 0.85325" + / - 0.00075, and the corresponding area in the hub is 0.850" +0.004", + 0.0025". The axle is "too large" and therefore has to be pressed into the hub.

We have the original factory blueprints for both parts. On the axle, the distance across the crests or raised flats is 1.0" +0.0" -0.015". The corresponding point (the root or groove) in the hub is 1.02", + / - 0.010". The table below uses the tolerances to determine the minimum and maximum dimensions for the parts.

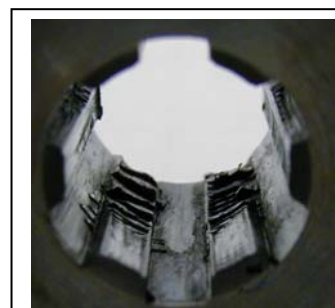
453-185\_Instruction Fig 5

Please note: In every case we are aware of where the axle was pressed dry, galling of the splines in the hub has occurred. In some cases the hub is so badly damaged it cannot be used (Fig 5).

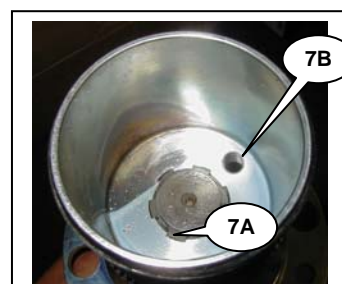
453-185\_Instruction Fig 7

About that leak. As previously noted, there is a gap between the crest on the axle and the root on the hub that is inherent in the design of the hub. There are several solutions that people have come up with, including stuffing a tennis ball inside the hub, or smearing a bead of silicone sealant on where the axle disappears into the back of the hub. Malcolm Green describes a fix in his book MG T Series Restoration Guide on page 39 which can be summarized: Degrease the inside of the hub. Cut a piece of cardstock to fit inside the hub. Squirt RTV silicone sealant down inside the hub and press the disc of cardstock down onto the silicone and let it cure. Malcolm acknowledges the grease fitting (it screws into the tapped hole 7B) is there, but he feels the amount of oil getting to the bearing makes the grease fitting redundant.
