**Supplemental Information**  
**for**  
**806-785 (two of 14B5494) Scuttle Seal Set**  
**805-185 (14B5496 and 14B5499) Bracket Set**  
**Austin Healey 100 BN2 from body number 11143**  
Retro-fitted by the dealers to the BN1, early BN2

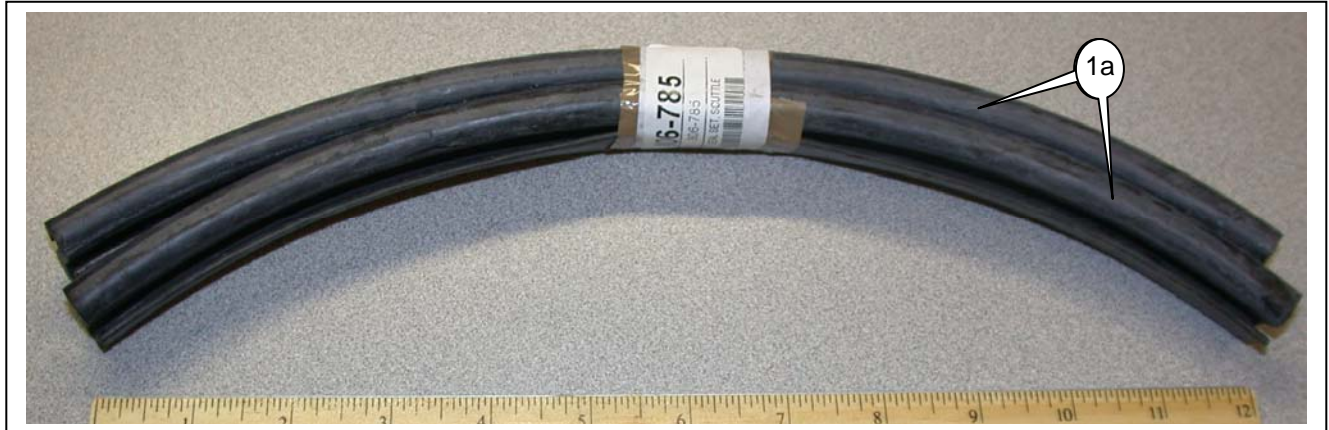
We offer the scuttle seals in a pair (1a). Each piece is long enough to do one side of the car. The scuttle area on the BN1 and the early BN2 had problems with water leaks where the fender, cowl, and front end of the door come together. At body number 11143, the factory introduced a scuttle seal that consisted of a flat strip (2a) that was hidden behind the front flap (2b), which incorporated a rain channel or gutter (2c). The scuttle seal was secured by a metal bracket that was hidden inside the channel (2d).

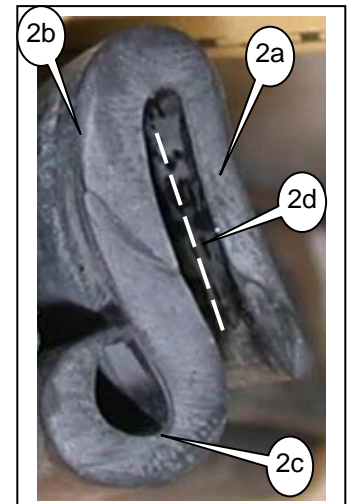
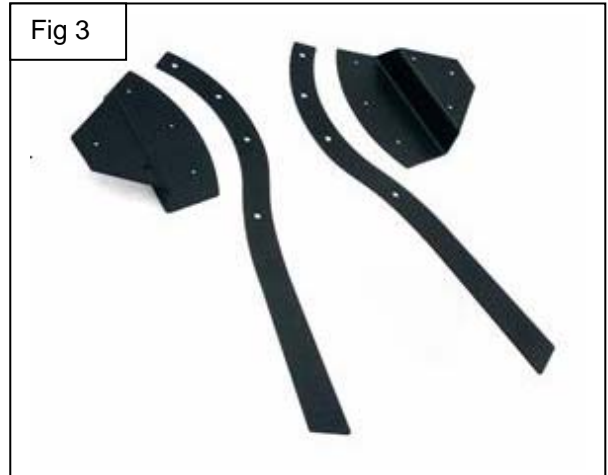
These seals are retained by special brackets that are secured to the fender and the shroud edge. The OE numbers 14B5496 and 14B5499 have been NLS for decades. We buy ours from Kilmartin in Australia. They are sold as a set of four brackets under 805-185 (Fig 3).

The scuttle seal extends down along the upper curve of the front fender, and is held in place by the bracket that screwed to the hinge pillar and the other bracket secured along the shroud edge.

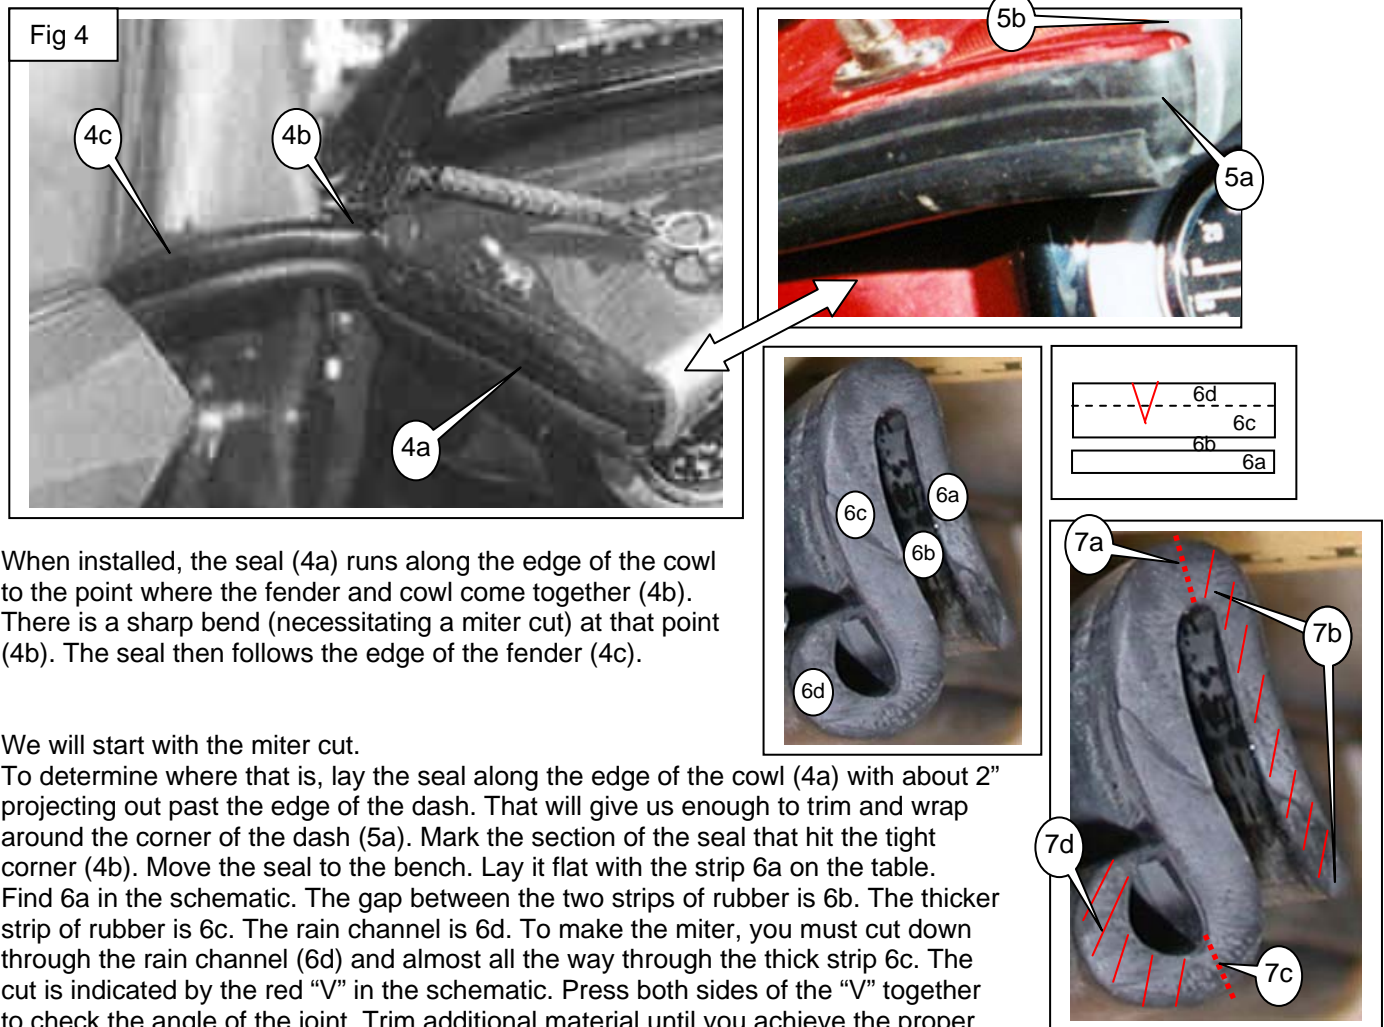
78 When installed, the seal (4a) runs along the edge of the cowl  
79 to the point where the fender and cowl come together (4b).  
80 There is a sharp bend (necessitating a miter cut) at that point  
81 (4b). The seal then follows the edge of the fender (4c).  
82  
83

85 To determine where that is, lay the seal along the edge of the cowl (4a) with about 2"  
86 projecting out past the edge of the dash. That will give us enough to trim and wrap  
87 around the corner of the dash (5a). Mark the section of the seal that hit the tight  
88 corner (4b). Move the seal to the bench. Lay it flat with the strip 6a on the table.  
89 Find 6a in the schematic. The gap between the two strips of rubber is 6b. The thicker  
90 strip of rubber is 6c. The rain channel is 6d. To make the miter, you must cut down  
91 through the rain channel (6d) and almost all the way through the thick strip 6c. The  
92 cut is indicated by the red "V" in the schematic. Press both sides of the "V" together  
93 to check the angle of the joint. Trim additional material until you achieve the proper  
94 fit. Once you have it so it fits, carefully super glue the two sides of the "V" together.

95 Now to the end that wraps around the corner of the dash. Trim the strip (7b) flush with the front edge of the  
96 dash by carefully cutting the seal along the line (7a) for about 1 ½ inches. Give some thought as to how this  
97 will look when you are done, and be very careful. Take your time. A single edge razor blade will do the trick.  
98 Trim the rain channel (7d) back the same distance by cutting back on the line 7c. This leaves a flat strip of  
99 rubber about 1 ½ inches long. This flap (5a) is then folded over to hide the raw edge where the first flap was  
100 trimmed (7b). This flat strap is secured by a #6 raised head Phillips screw, about 1/2 - 3/4" long. The  
101 aluminum cockpit molding (5b) is then installed, covering the end of the flat strap of rubber (5a) and the screw  
102 securing the strap to the dash. Once the aluminum cockpit rail is secured, you will have a nicely finished
