## Supplemental Information for 021-511 or 120694 Angle Drive (Speedometer Cable to Gearbox) Austin Healey BN4-BJ8, MGB 63 on, TR'S 63 on

# TECHNICAL SERVICE BULLETIN

Re: Right Angled Speedometer Adaptor Failures

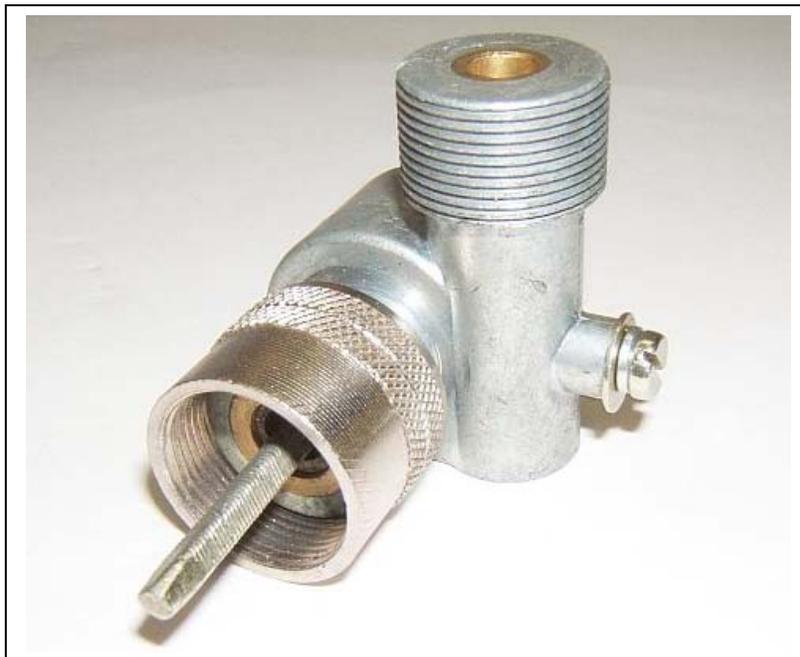
This speedometer angle drive was fitted to many British cars where there was insufficient room to run the speedometer cable directly into the gearbox.. The original angle drives quickly developed a reputation for being prone to failure. This resulted in a thorough investigation that in the end resulted in the Technical Service Bulletin (TSB) of February 29, 1968. The TSB (copy on the next page) explains that the 324-720 or 3H550 “washer-adaptor to gearbox” **must** be fitted with the angle drive. If the washer is left out, the end load on the angle drive will be excessive and it will fail. When we first offered our reproduction of the 120694 angle drive, we included information in the catalog and with the part regarding the necessity for the washer.

Repeated failures of the above have, in many instances, been caused by Washer-Adaptor to gearbox Part Number 3H 550 not being fitted when a new right angled drive adaptor is installed.

This causes an excessive end load and premature failure of the right angled drive pinion.

***IMPORTANT! When fitting the angle drive, fit a 324-720 or 3H550 washer as shown on the next page.***
