License Lamp Harness w/Fuse

Installation Instructions

PART # 356-375 or AHB7117

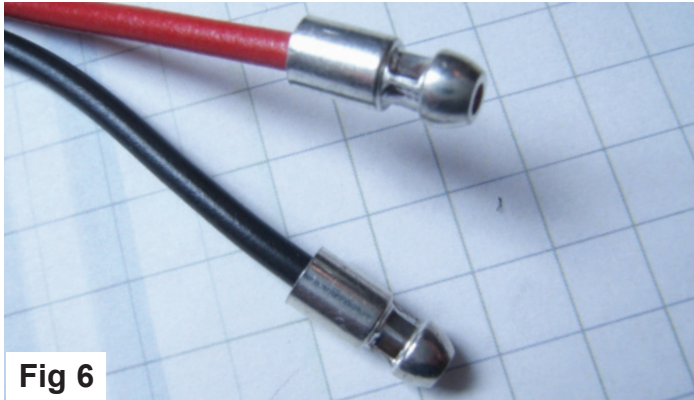
Fig 6

This harness replaces the two-wire harness running to the license lamp. The Wires with the crimped on bullets (Fig 6) plug into the trunk harness, Red to Red, Black to Black.
