Supplemental Information & Instructions for 384-930 Steering Wheel Puller MGB 77-80 With the Original Rubber Wrapped Steering Wheel

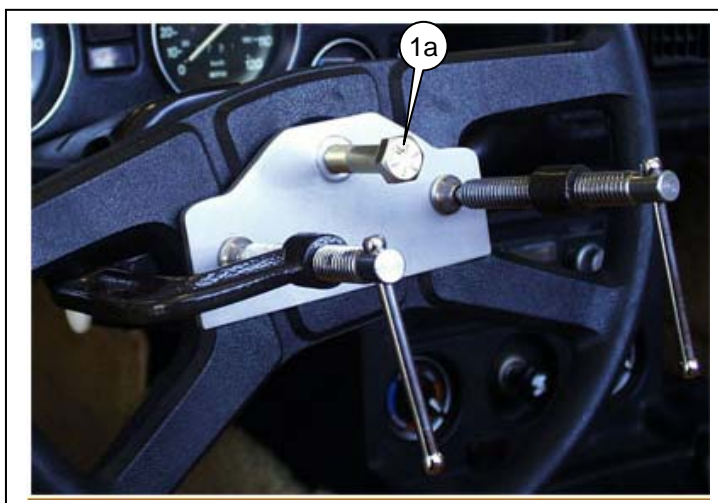
Position the puller with the threaded hole for the push bolt (1a) directly over the end of the steering shaft. Position the "C clamps" as shown in the photo, and tighten them so the puller is held firmly against the wheel. Tighten push bolt (1a) so that it makes contact with the center shaft and nut. Tighten it some more. If the wheel does not come loose, a few blows with a heavy hammer on the push bolt of the tool may be needed. The shock of the blow will tend to loosen the most stubborn wheel.
(NOTE) If replacing turn signal assembly, ensure upon installation that the tab or rib on the plastic center hub faces the lever on the turn signal switch (the left side of car).

Gently, pry out center MG logo.
Back off steering wheel nut until it is approximately 1/2 off the end of the threaded steering shaft.
Mark hub of steering wheel and the end of the shaft with a witness mark, (white out or permanent marker works well) to facilitate re-alignment of the wheel when you re-install it.
Put a small amount of penetrating oil or WD-40 on the splines. The oil will seep down between the splines on the shaft and the splined hub of the wheel, and will help loosen the wheel.
