Regulator Interchange

Part # 141-900

Instruction sheet #980-049 1/98

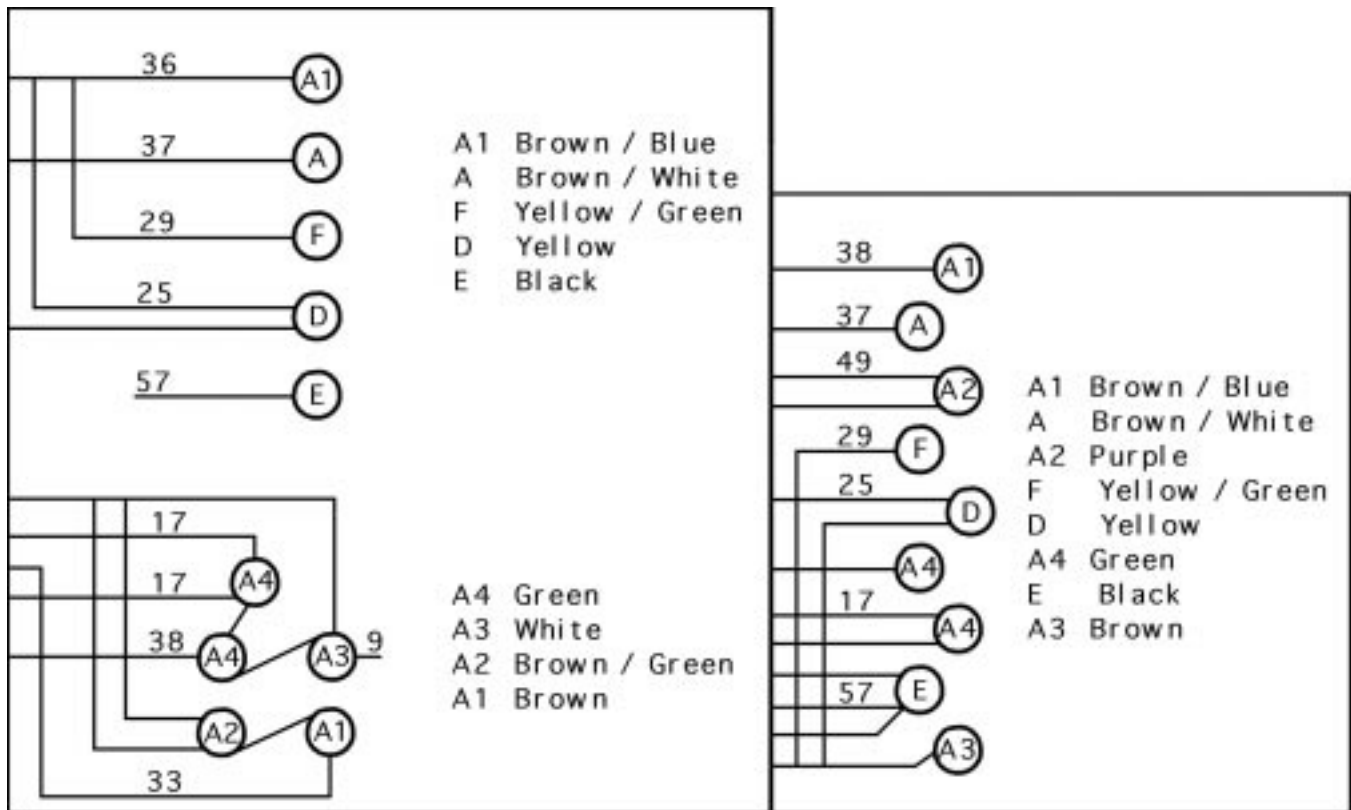
The Lucas RF 95/2 (Moss Part Number 141-900) nine post regulator which incorporated a fuse box was replaced in 1951 by the Lucas RB 106/1 (142-000) regulator and SF6 fuse box (162-500). The nine post has since become a rarity. It is perfectly acceptable to replace a bad nine post regulator with the later regulator and fuse box. No permanent modification need be made; the wiring remains the same (except for a change of color in the horn wires) and nothing need be deleted or added. If a working nine post is found; it is an easy matter to revert to the older system. The newer parts may be kept as spares.
