## **Premium Clutch Kit**

PART# 190-807

## Installation Notice

For: MGB, 1962-80

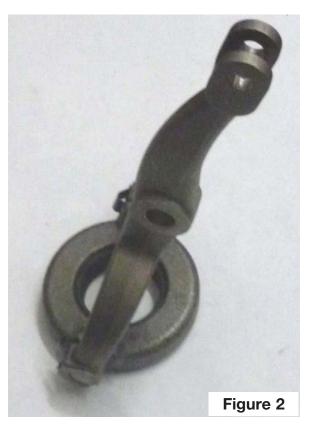
Squeezing clip tighter to increase tension

Fitment of T-brg on T-arm is easiest to verify with T-arm removed from gear box. T-arm is easy to remove; 1 bolt.

With T-arm removed, ensure that clip tension is sufficient to enable the T-arm to stand on T-brg on a table easily without T-brg rotating and allowing T-arm to fall.

In some cases it may be necessary to squeeze the clip form with pliers to increase the tension of the clip to retain the T-brg on the T-arm.

This is an easy process with little risk of damage to the clip, but does require a minor degree of finesse with the pliers.
